# Kenilworth River Park Bank Stabilisation Project

# Erosion Repair at Kenilworth River Park (Charles Street)

# Overview

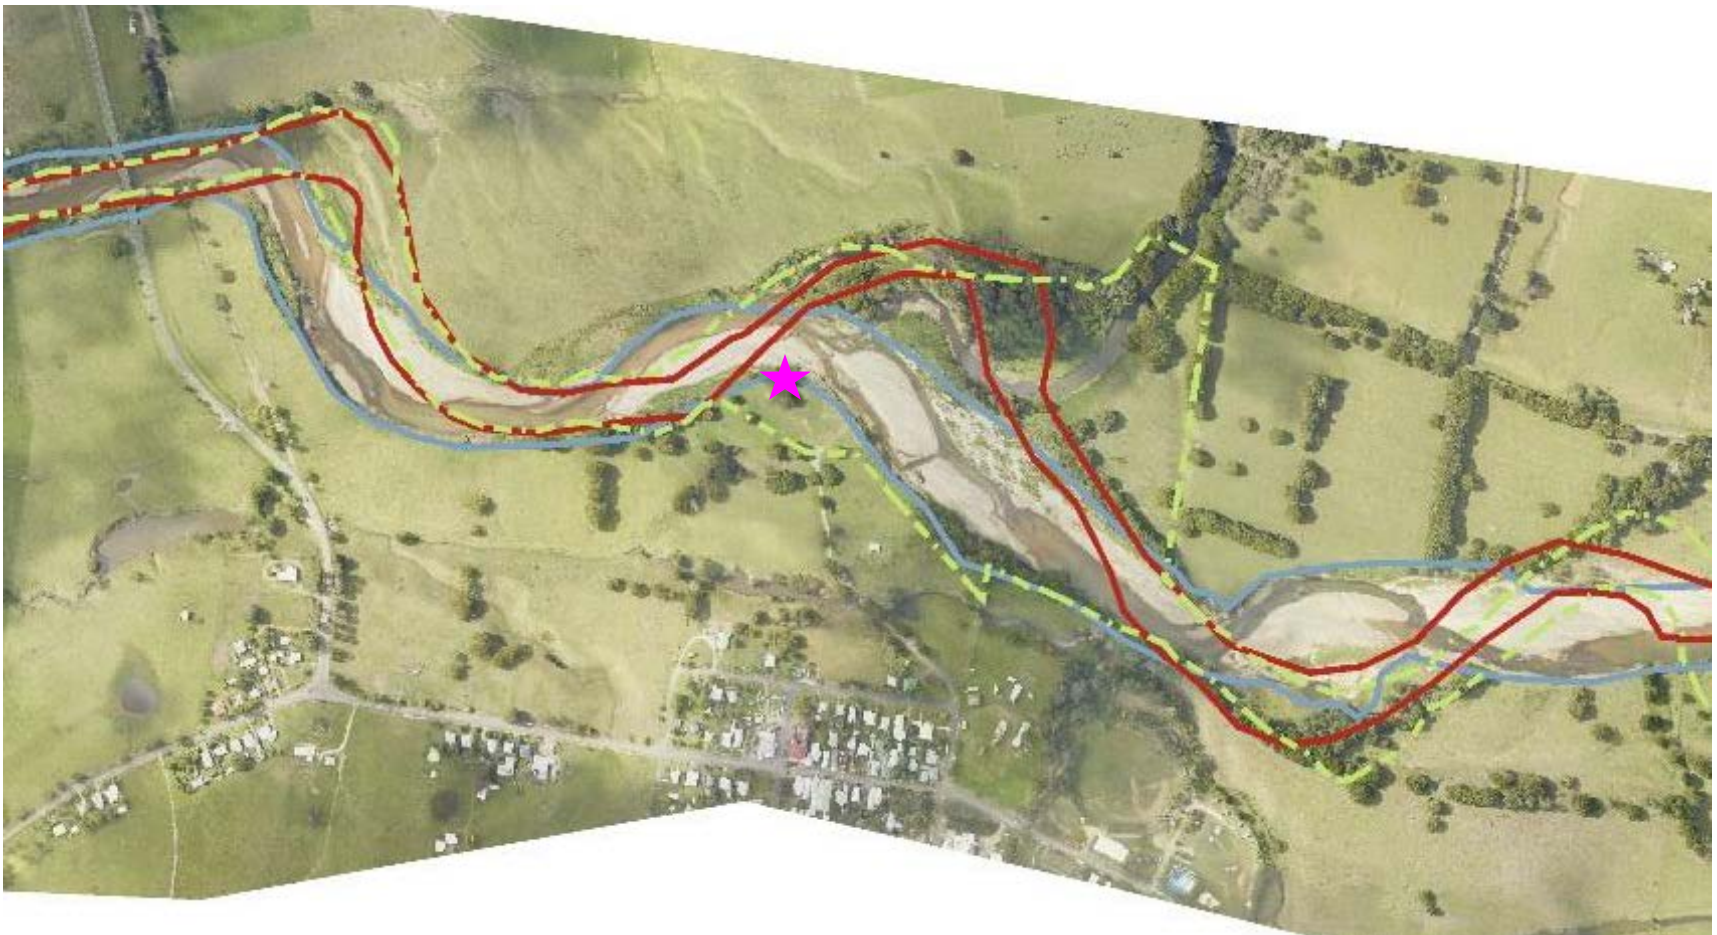
# What are the processes occurring?

- River widening and straightening

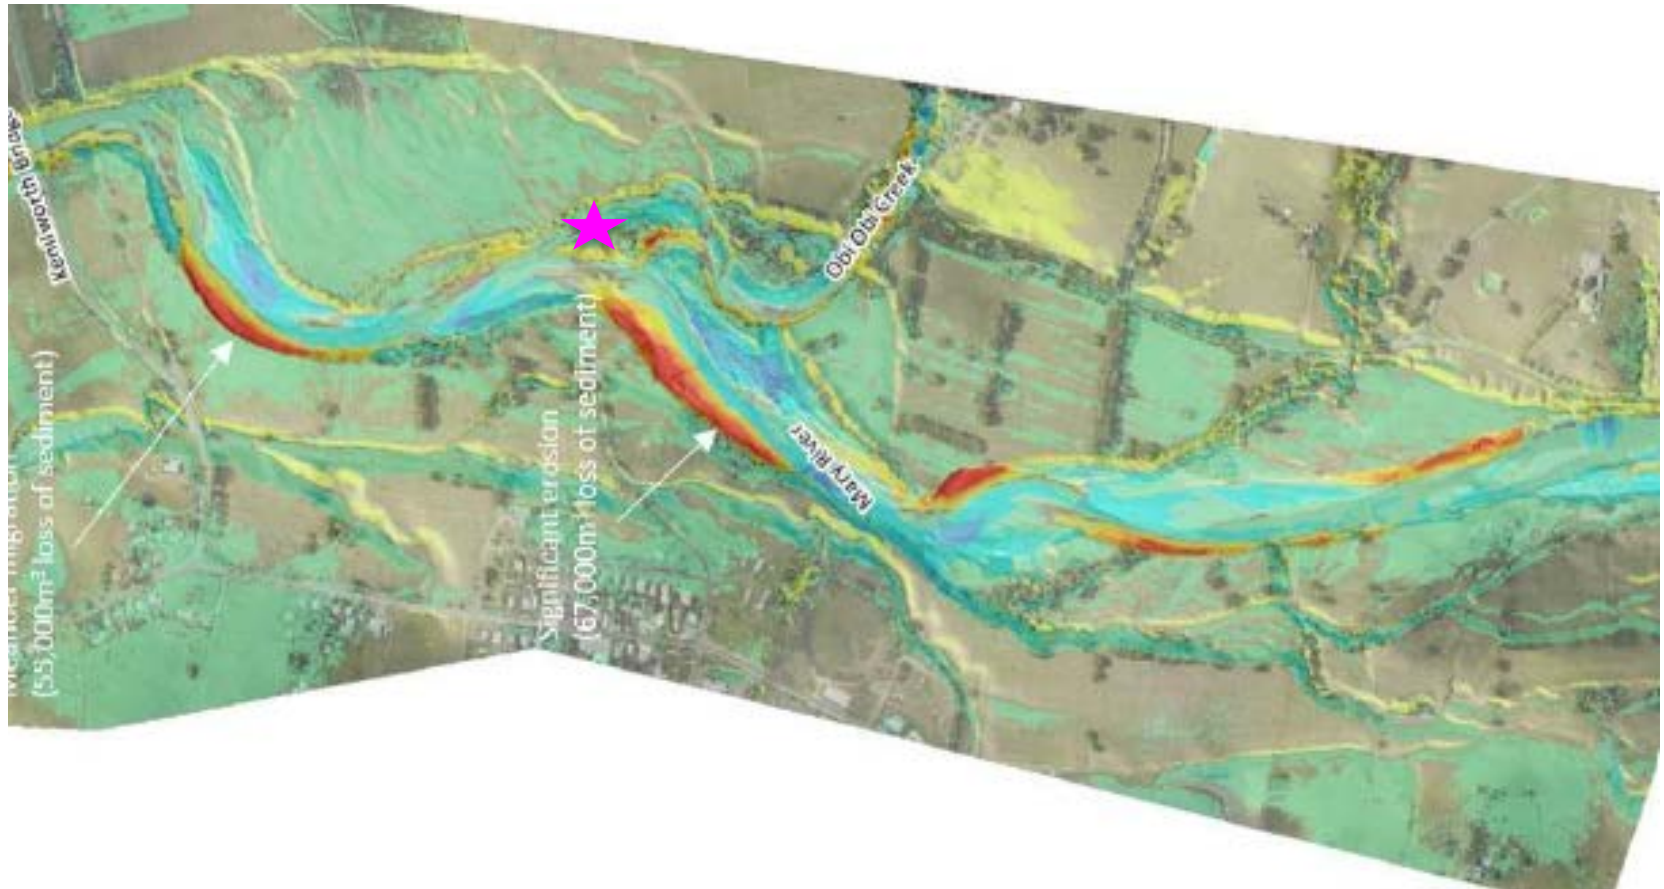
# What are the processes occurring?

- This has led to a situation where excess power is exerted on the stream banks and meanders are starting to reform

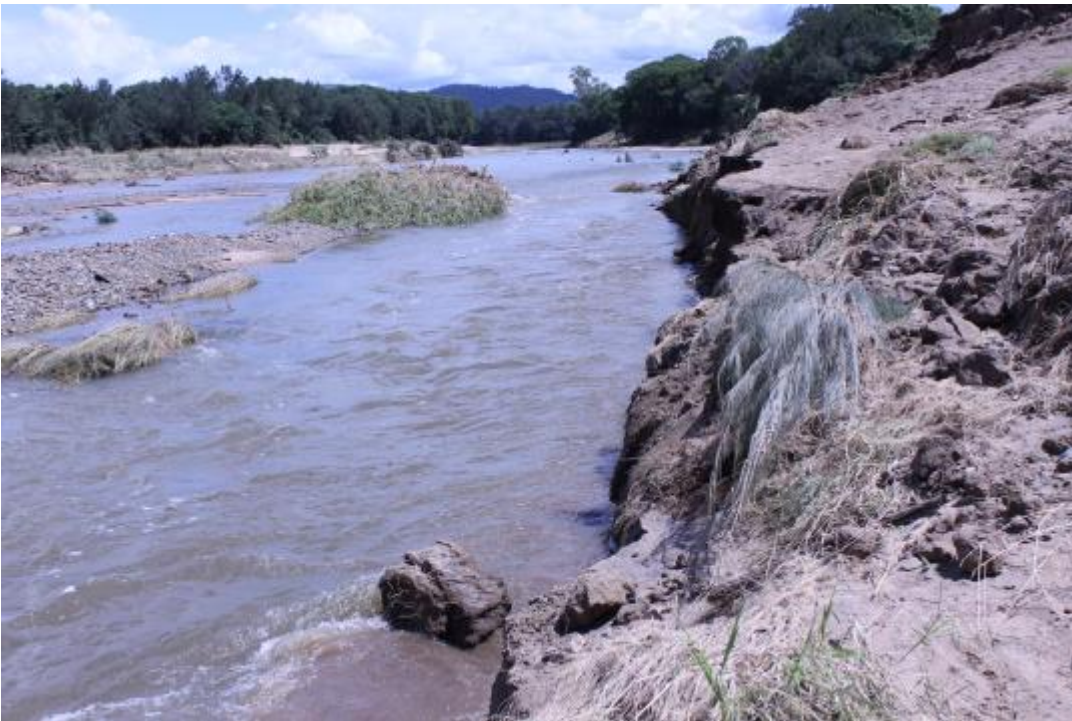
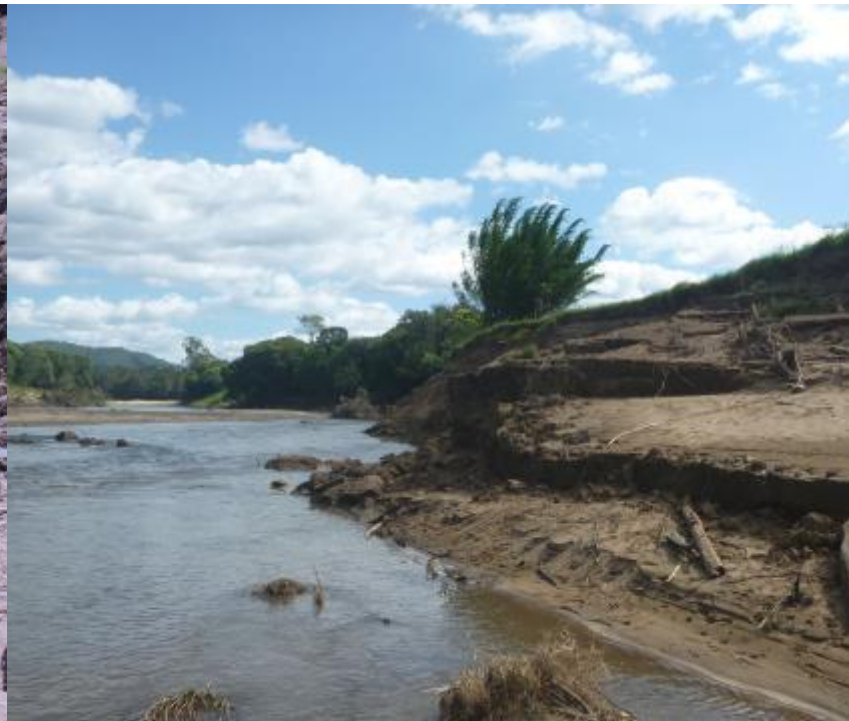
# Tropical cyclone Marcia

Loss of stream bank in 2015 after Cyclone Marcia

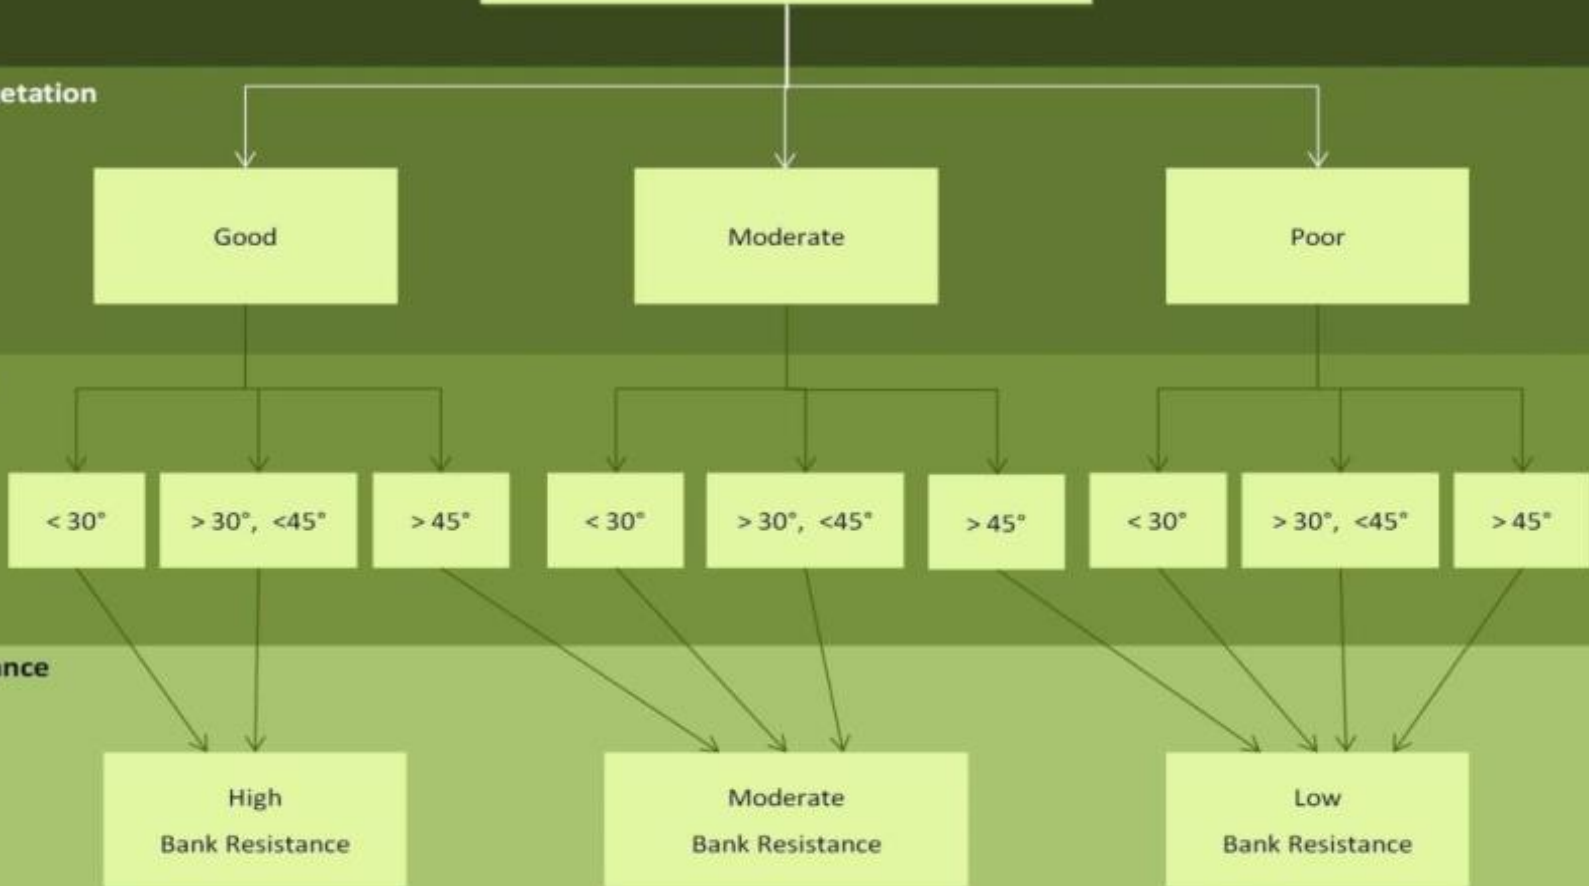
# Bank stability

What is the riparian vegetation condition?

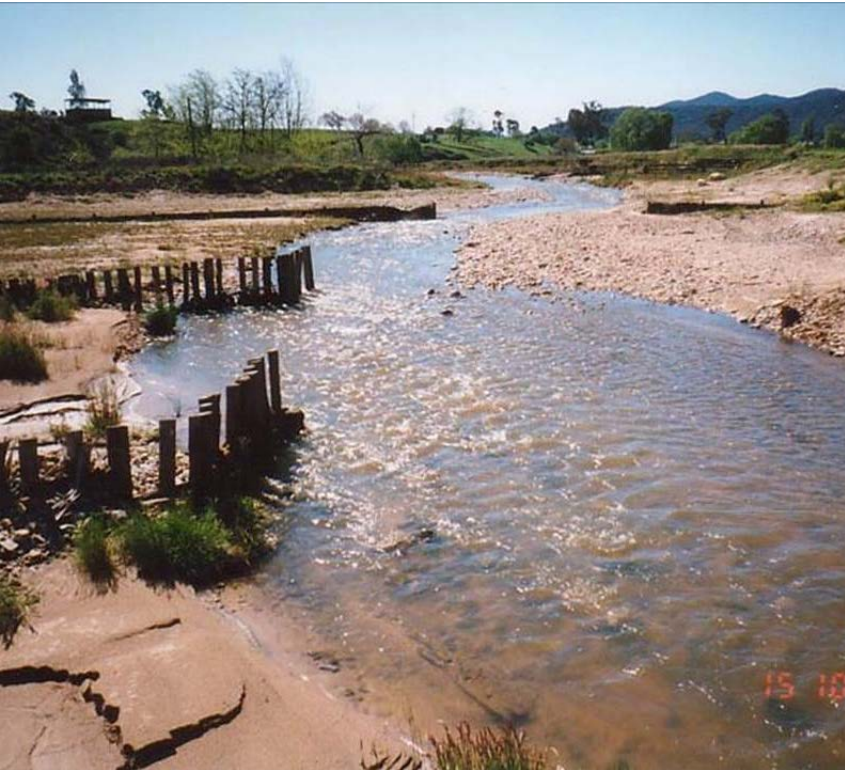
Newly installed pile field

- Mary River Turtle
  - The design has been influenced so as not to impact on potential nesting areas for the MRT. Limited rock revetment at the toe to provide access to the sandy banks, use of pile fields as the preferred option for stabilisation of the toe of bank.
  - The Mary River Turtle nesting period is from October to January. Nesting is triggered by storm rains in October.
- Rainbow Bee Eaters
  - Were actively using the bank prior to the last event, they finish nesting in January and start again in August.
- Riparian restoration to the bank is critical to the success of this project

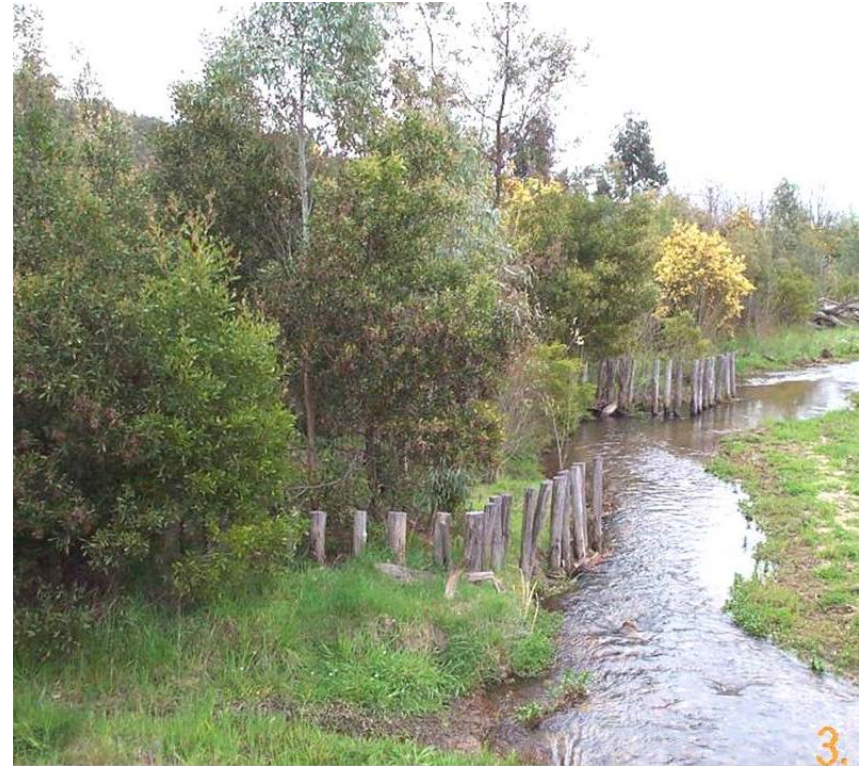
Established pile field
